REPORT NO. 8-60-50G-III

MONTHLY PROGRESS REPORT

ENGINEERING PROGRAM FOR
THE PILOT PRODUCTION OF A
LIGHTWEIGHT ANTITANK WEAPON

MONTH OF AUGUST 1960

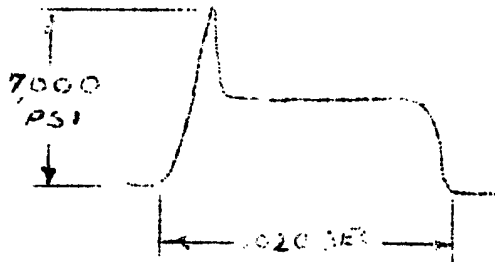
to a curve obtained at the cold temperature having this shape:

The peak formed at the beginning of the burning time is more pronounced at the cold temperature.

This sudden loading and unloading creates a stress condition on the vessel containing the pressure which is very difficult to evaluate fully. The sudden unloading after a very short duration of the peak pressure may set up stresses caused by oscillation far in excess of anything created by the nominal value of the peak pressure. In addition to this consideration it is possible that since the peak rises so suddenly the curve in some one rocket may keep on going up higher than average, thus creating an excessive peak pressure.

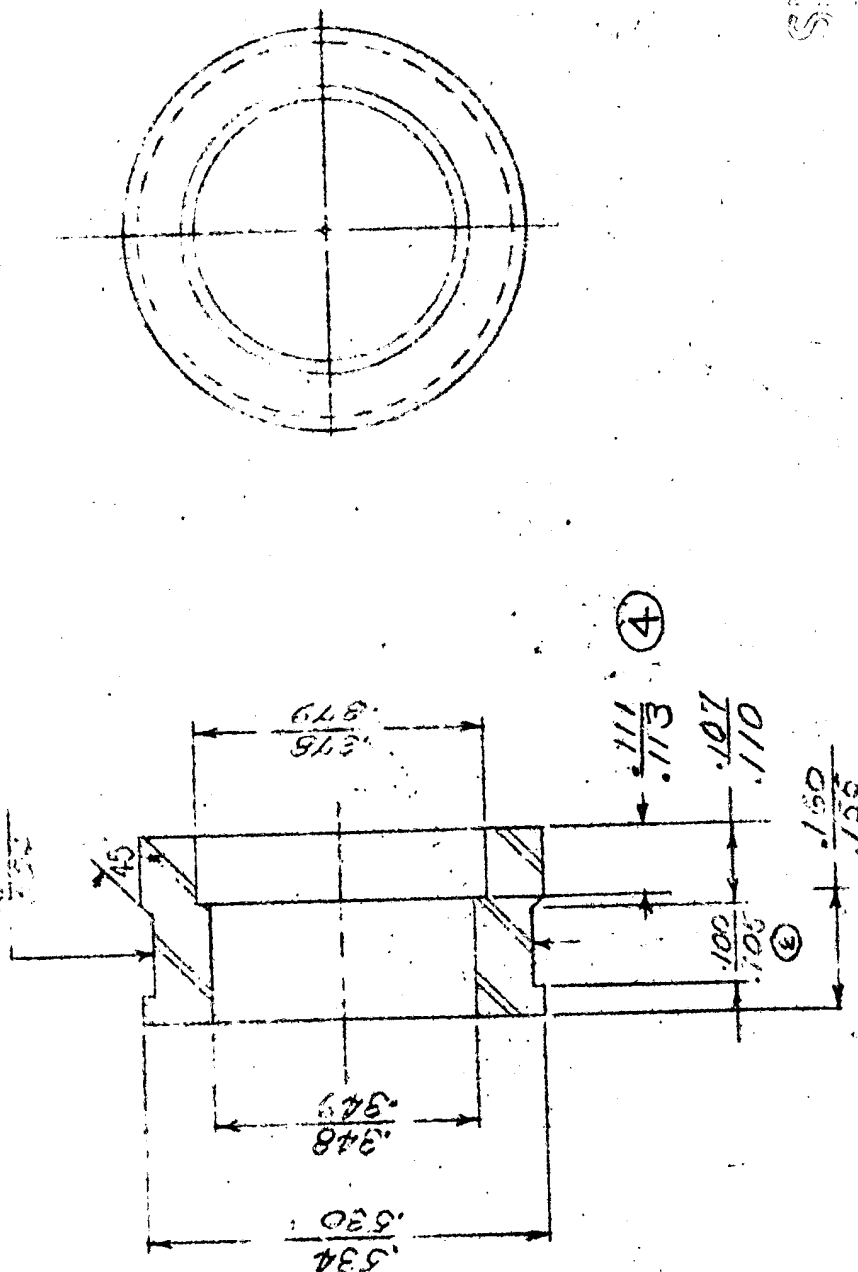
REVISIONS	
4	WAS .092 B 2260
3	ADDED 7/24/58
2	WAS .120 K.H.
1	REPLACED K.H.

A study of the room available for the additional lead ring and of the maximum and minimum size of this ring has shown that, by machining the triggering sleeve slightly deeper in one direction (Dwg. No. A-8153, Rev. 4, Appendix), safe and consistent functioning may be established. The drawings have been accordingly changed and the re-machining of the triggering sleeves ordered.

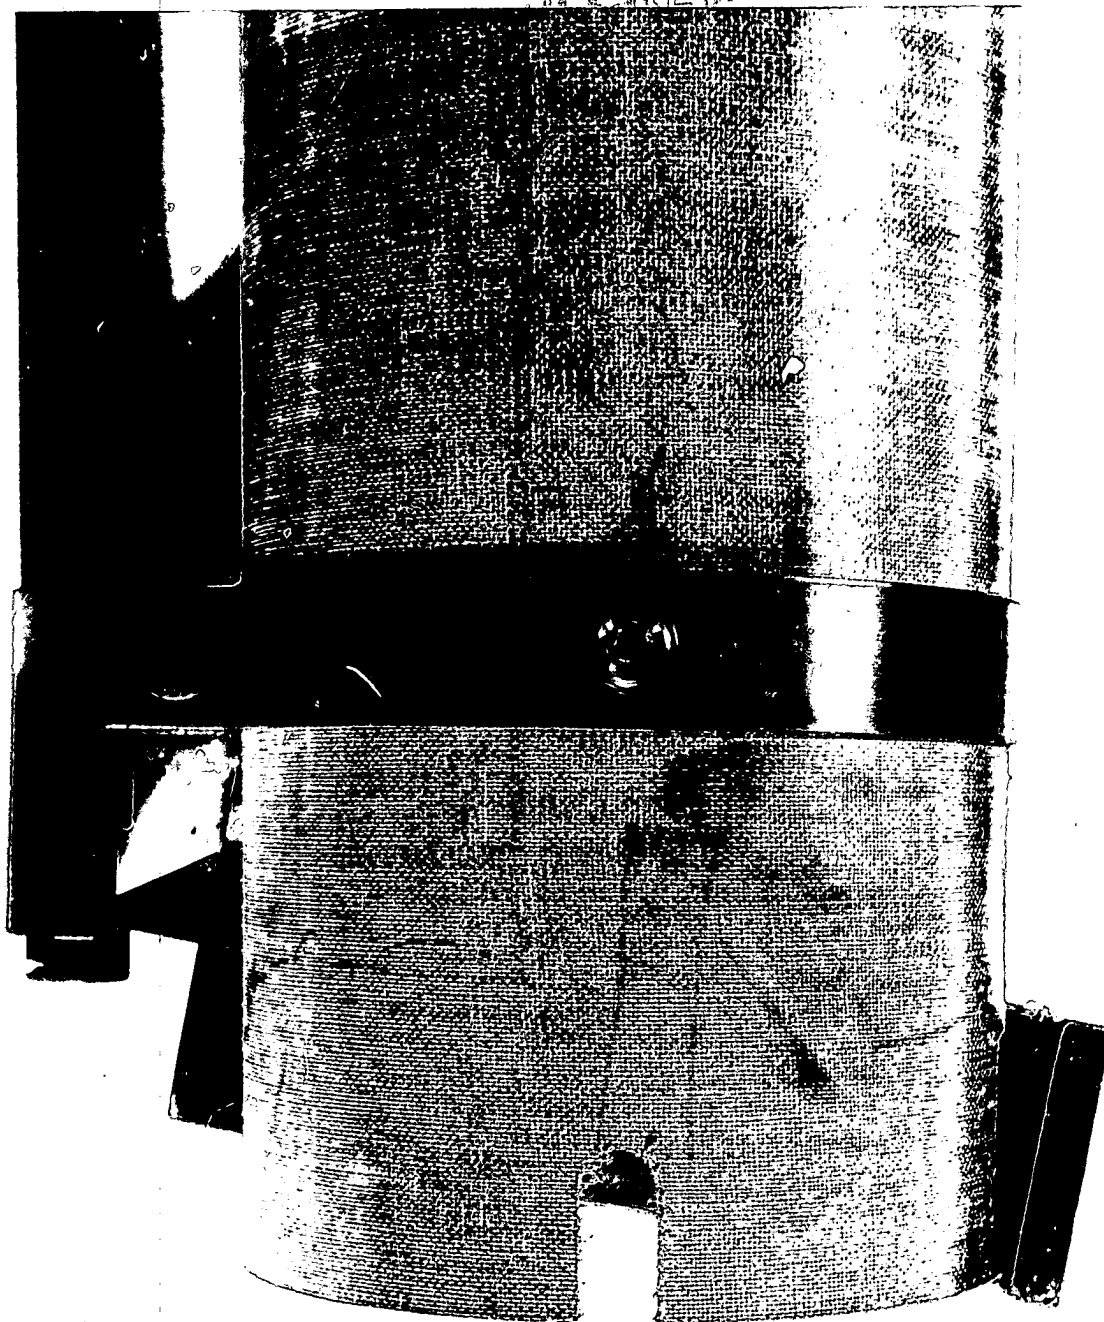
Photo No. 2

When conducting the fuze test at the cold temperature on 5 August, it was found that erecting the trigger handle caused so much friction in the swivel sleeve assembly (the assembly in the rear of the launcher which operates the actuating lever in the igniter assembly), the actuating lever was prevented from properly operating and pushed over to one side to such an extent that it jammed in the rear band around the launcher. Investigation showed that the location of the swivel sleeve in the case of most of the launchers assembled to this point was improper. This had been caused by the operator pulling the locating fixture, which is used to locate the swivel sleeve, forward of the launcher when assembling the firing mechanism assembly.

Exaggerated demonstration
of possible misalignment
using old tool.
